Inspection Report

Minerals Regulatory Program Date of Report: May 7, 2008

Mine Name: Dry Wash
Operator Name: Miracle Rock Mining
Inspection Date: April 21, 2008
Time: 2:15-2:50 PM

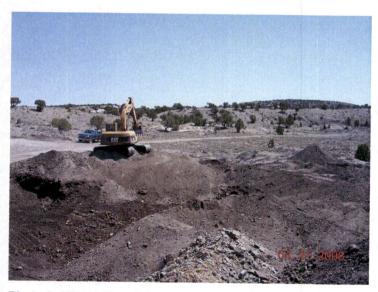
As can be seen in the photos, the operator has pulled back soil and overburden and is mining with a trackhoe.

Photo 1. The active mining area.

The operation appears to be in compliance with the rules. As areas become available, I suggest the operator do as much contemporaneous reclamation as possible, but surface preparation and seeding should be done in the fall.

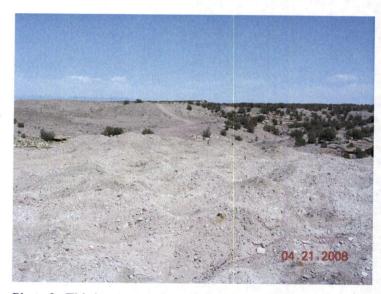
The mine contains two areas separated by a road. The more recent disturbance is on the west side of the road. It appears the operator has pulled back a spoil pile in the area on the east side of the road although it did not appear to have been seeded.

Photo 2. This is an area where I thought it looked like overburden had been pulled back, possibly in preparation for, or as part of, reclamation.

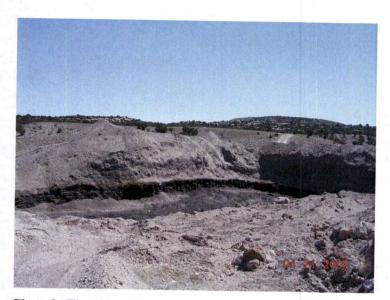
Photo 3. The older pit on the east side of the road.

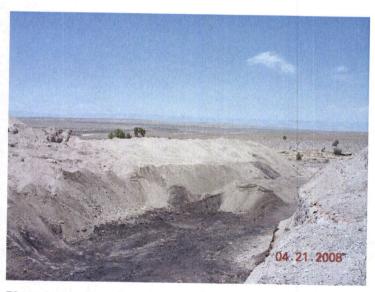
Photo 4. Another view of the older pit.

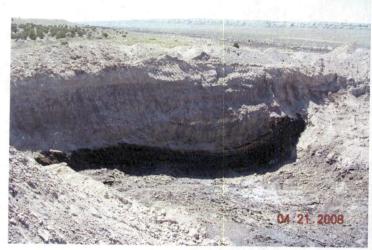
Photo 5. The ore within the older pit.

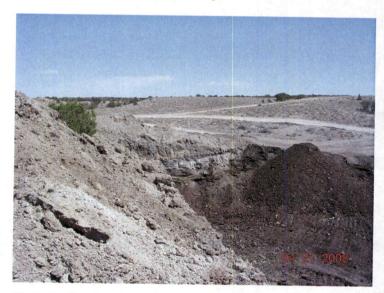
Photo 6. Overburden on the left, ore on the right in the newer pit.

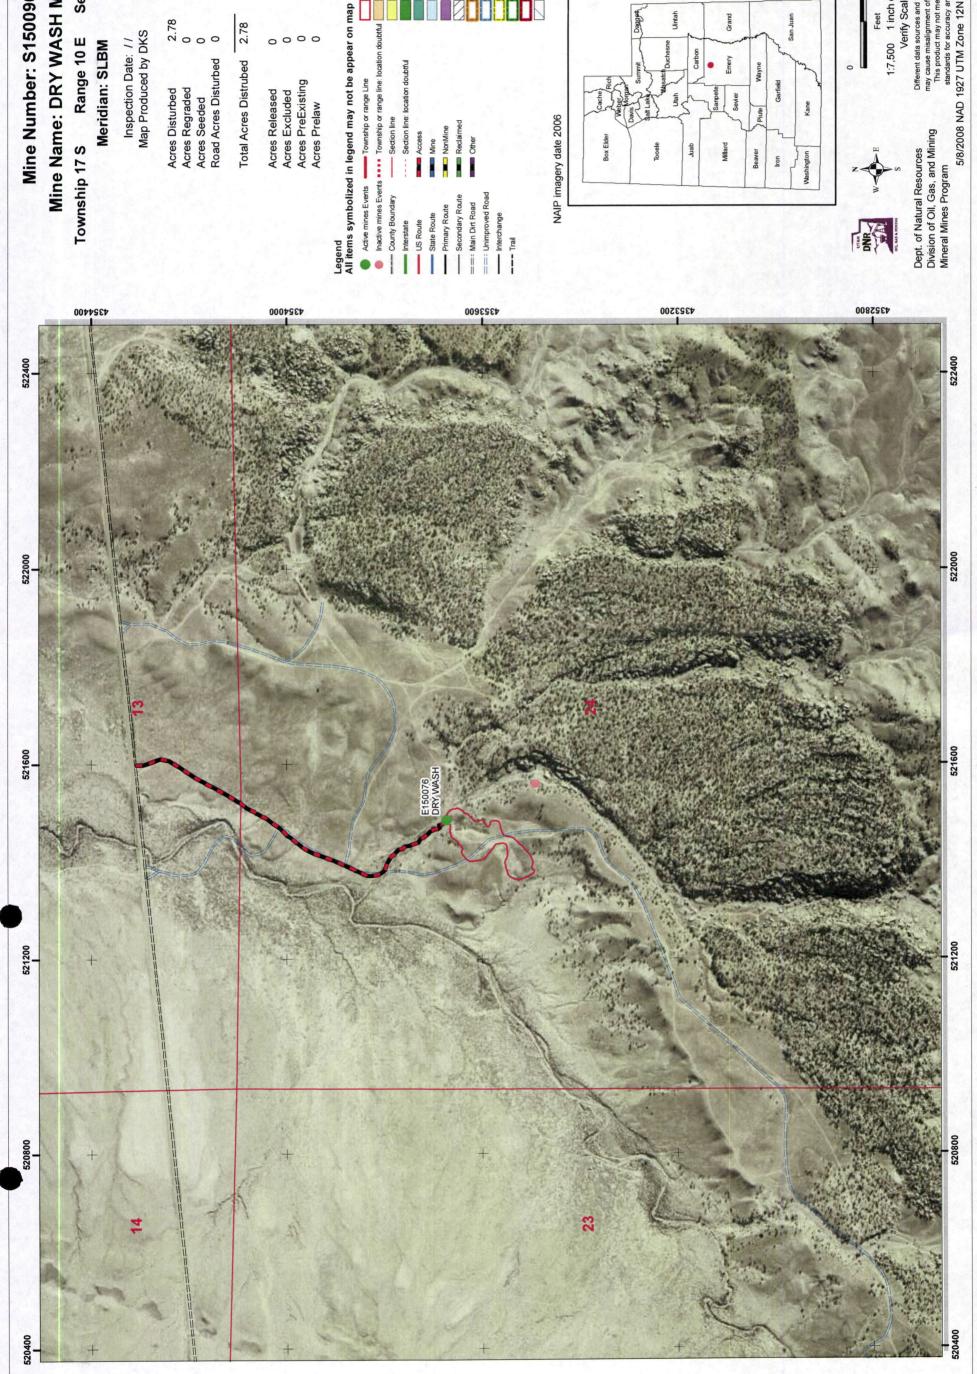
I used a GPS unit to map the disturbed area, and it is about 2.9 acres.
